**Examination of naturally weathered REFOS
secondary concentrators.
SFERA Project WP13, Task 2, Subtask “Hardware”**

Authors: A. Fernandez-García (CIEMAT), M.E. Cantos-Soto (CIEMAT) and T. Denk (CIEMAT)

Date: September 26th, 2011

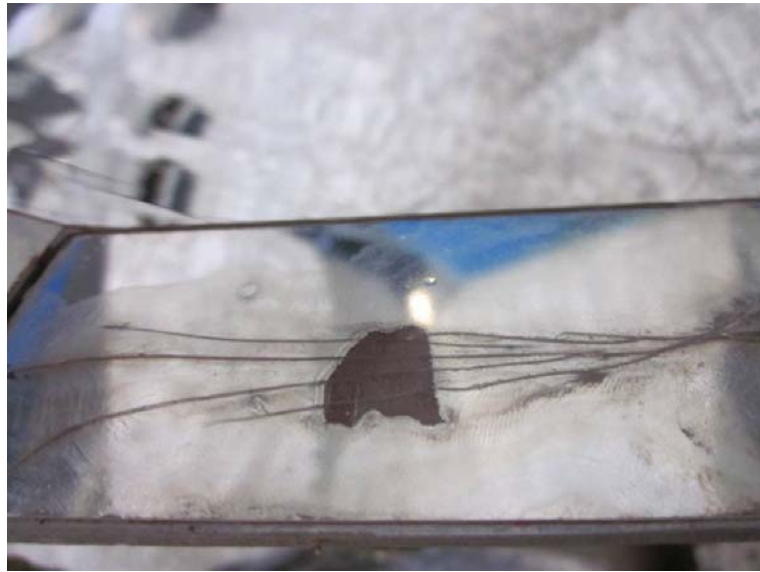
- **Inner silver corrosion with glass cover breakage.** It was observed that the corrosion started at the center of the mirror segment and not at the edges. This is very probably due to the previous mirror breakage and humidity penetration as Figure 3 shows:

Figure 3: Inner silver corrosion with glass cover breakage

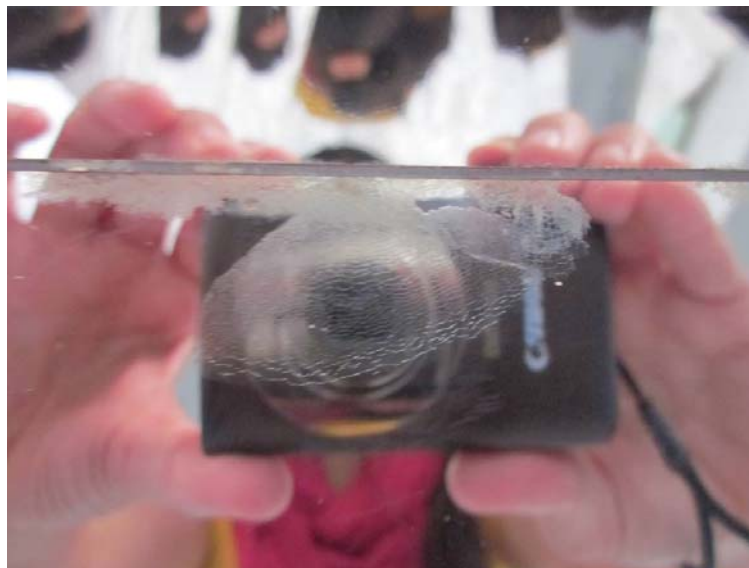
- **Edges' silver corrosion.** This was the most frequent degradation pattern. It was observed that the joints suffered some adhesive losses. Therefore, it was reasonable to understand that the silver deterioration started in the same area. This deterioration was more aggressive in the mirrors placed upside down on the ceiling of the concentrator and in the ones with certain slope as shown in Figure 4.

Figure 4. Edges' silver corrosion

- Joint sealing reinforcement. To investigate about other more durable sealing materials could be an advantage against the mirror edges decay.
- Use of back coated mirrors to avoid the corrosion.
- Avoid high mechanical efforts during manipulation/installation and adjustments. This is one of the most difficult tasks, due to the laboriousness of the building and installation process.

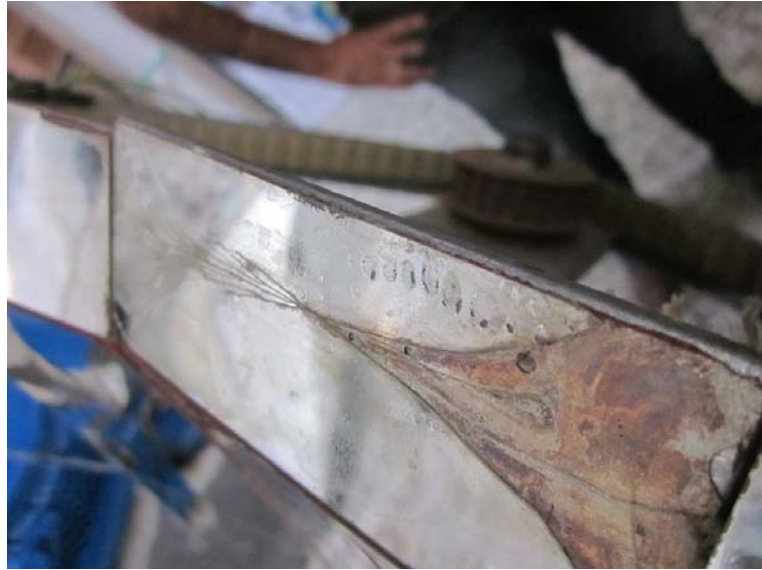
- **Edge and inner silver corrosion with glass cover breakage and glass cover losses.** Here the mirror losses observed in Figure 5 caused a quicker degradation of the silver.

Figure 5 Glass cover losses and silver corrosion.

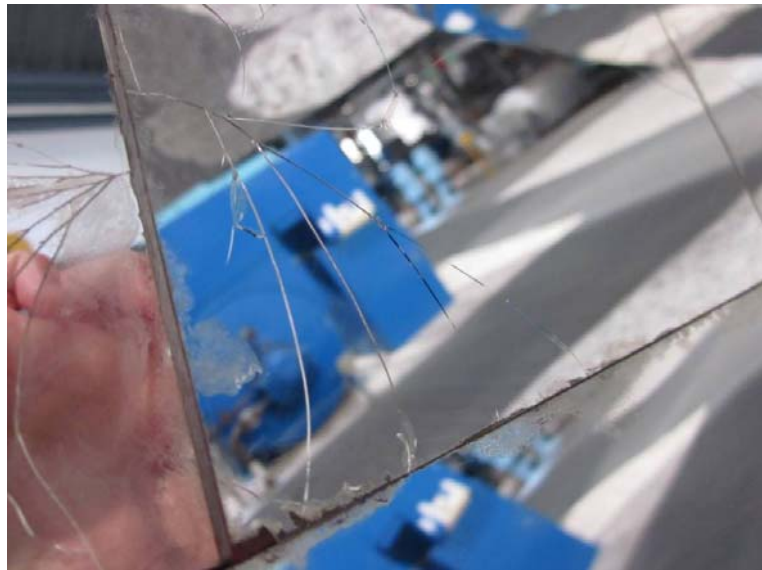
- **Glass cover breakage without glass losses.** Here below in Figure 6, there is no deterioration observed around the glass cover cracks but around the joints. One reason for not having silver corrosion could be that the glass breakage is not deep enough and has not reached the silver layer.

Figure 6. Glass cover breakage with no glass cover losses

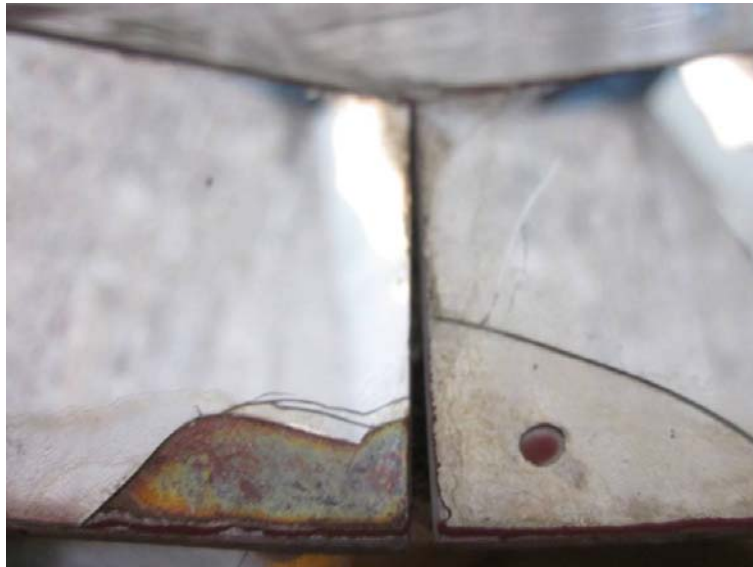
- **Joints degradation and silver decay with glass cover breakage.** The three previously mentioned decay patterns are observed all together in Figure 7.

Figure 7. Joints degradation
