SFERA (Solar Facilities for the European Research Area)

Final results of secondary concentrators solar mirror testing

(Work Package 13, Task 2, Subtask “Hardware”)

ID: SFERA-TE-CS-004

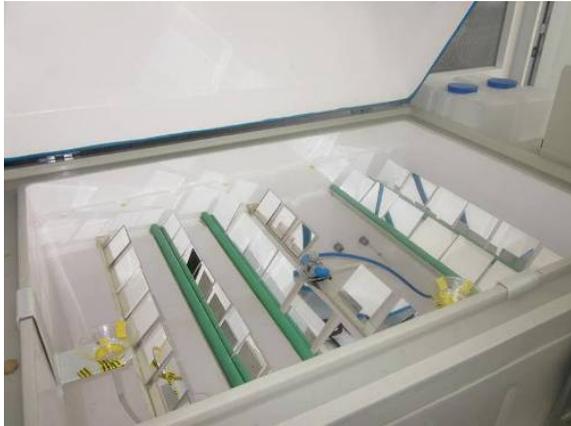
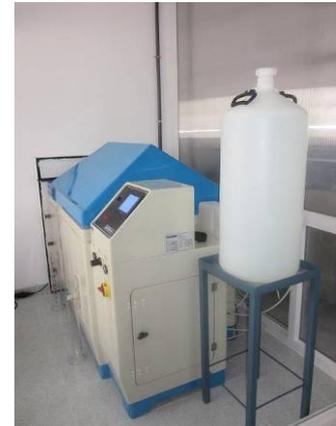
- Weathering chambers, to simulate the accelerated ageing conditions applied under specific settings (see figures 1 and 2):
 - Salt spray test chamber, CSF-500 by *Control Técnica*. This chamber has been manufactured to make tests according to DIN-50021 and ISO-9227 standards. Combined cycles can be programmed (salt spray, condensation and ambient conditions). Different temperatures can also be applied during tests, from 10 to 50°C.

Figure 1 Salt spray test chamber

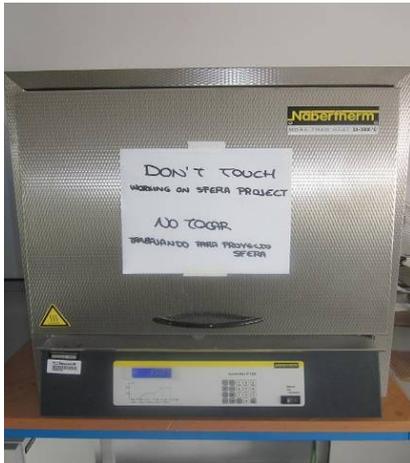
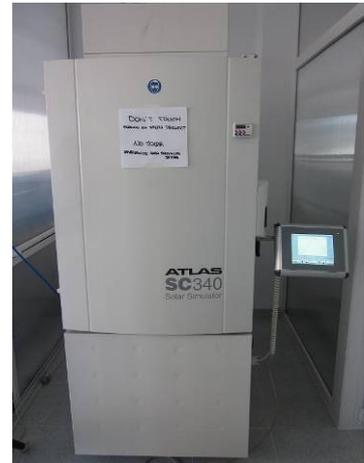
- Weathering chamber, SC340 by ATLAS. Several combinations of humidity and temperature can be applied, both in steady conditions and in cycling combinations. If only temperature testing is done, the temperature range is from -40 to 120°C. If temperature and humidity testing is done, the temperature range is from +10 to +90°C and the humidity range is from 10 to 90%.

- Muffle furnace, LT 40/12 by Nabertherm. Constant temperature tests can be done at temperatures up to 1200°C. Additionally, a special device has been developed by CIEMAT to carry out automatic temperature cycles tests. This device uses a conventional muffle furnace for the heat up cycle and a fan for the cold down cycle. In addition, water can be sprayed in the cold down cycle. The useful area is 30 x 45 cm.

Figure 2 Muffle furnace (left side) and weathering chamber (right side)

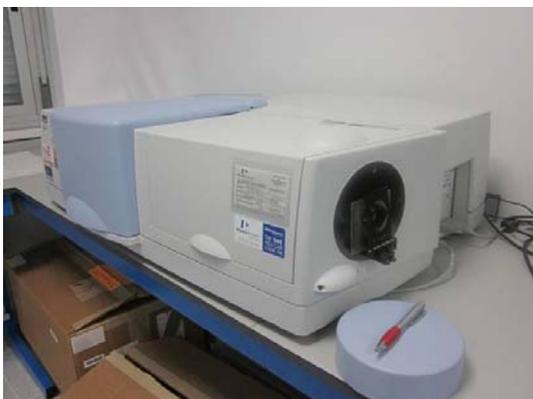
- Spectrophotometer, Lambda 1050 by Perkin Elmer with integrating sphere ($\lambda = 250-2500$ nm). The Spectral hemispherical reflectance, $\rho_h(\lambda, \theta, h)$, is measured with a Perkin Elmer Lambda 1050 (see Figure 3).

- Reflectometer, 15R-USB by Devices and Services. The measuring of monochromatic specular reflectance, $\rho_s(660nm, 15^\circ, \varphi)$, has been done with this instrument which allows taking the measurements at 1 wavelength ($\lambda=660nm$) and 3 aperture angles ($\varphi = 15, 25$ and 46 mrad) (see Figure 3).

Figure 3 Spectrofotometer (left side) and portable reflectometer (right side)

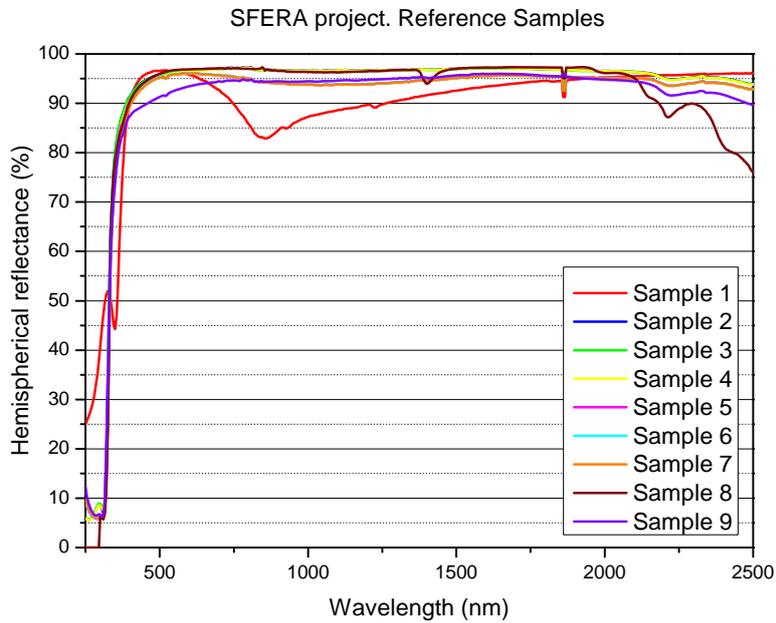
Further down, figure 4, offers the reference samples hemispherical spectral reflectance, $\rho_h(250-2500nm,8^\circ,h)$, plotted by the spectrophotometer in a graph. This figure shows the typical spectrum of silvered-glass mirrors (samples 2 to 9) and aluminium with special protection mirrors (sample 1). Reflectance spectrum of samples 2 to 8 are quite similar, having reflectance spectrum of sample 9 a deeper elbow in the visible range. Reflectance spectrum of sample 1 has a valley around 800 nm, as usual for this aluminium material.

Figure 4 Hemispherical spectral reflectance of reference samples

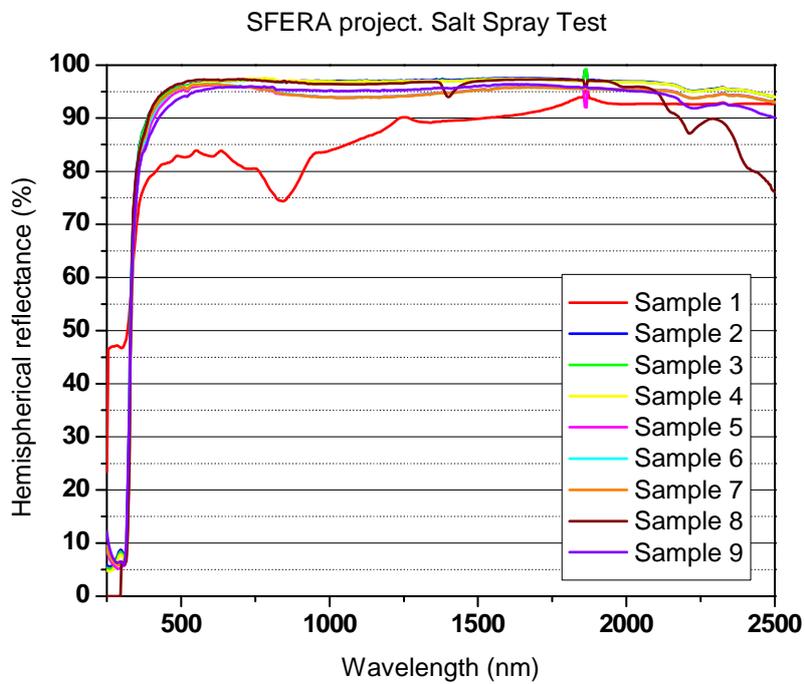
Figure 5 Hemispherical spectral reflectance after salty spray test

Then, from figures 5 to 10, the results for salty spray, constant temperature, temperature cycling, humidity, damp heat and muffle furnace high temperature tests, are respectively shown.

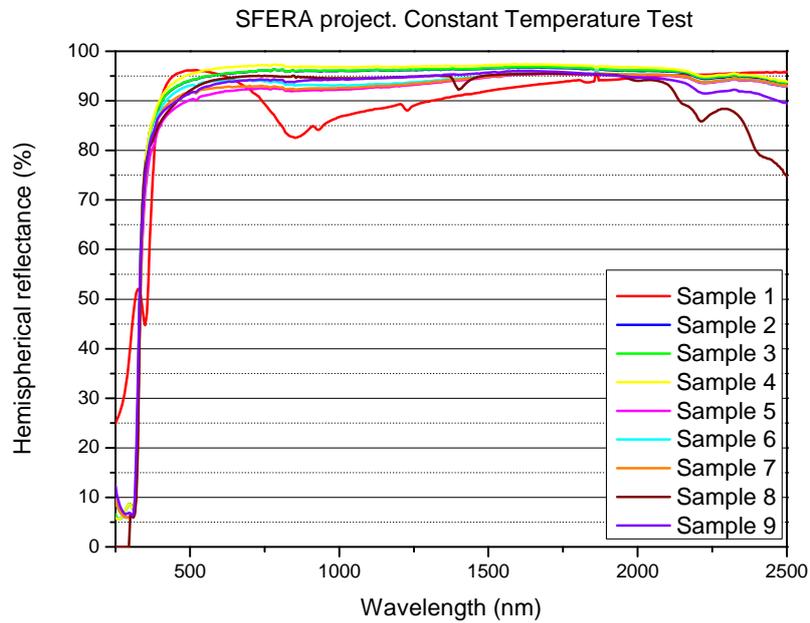
Figure 6 Hemispherical spectral reflectance after constant temperature test

- **Concerning combined weathering tests** of constant temperature, humidity and temperature cycling (see figures 6, 7 and 8), it seems that the manufacturer 4 and 1 have the best behaviour, with reflectance losses between 0.0 and 0.5%, followed by number 9, with a 0.7% maximum reflectance losses.

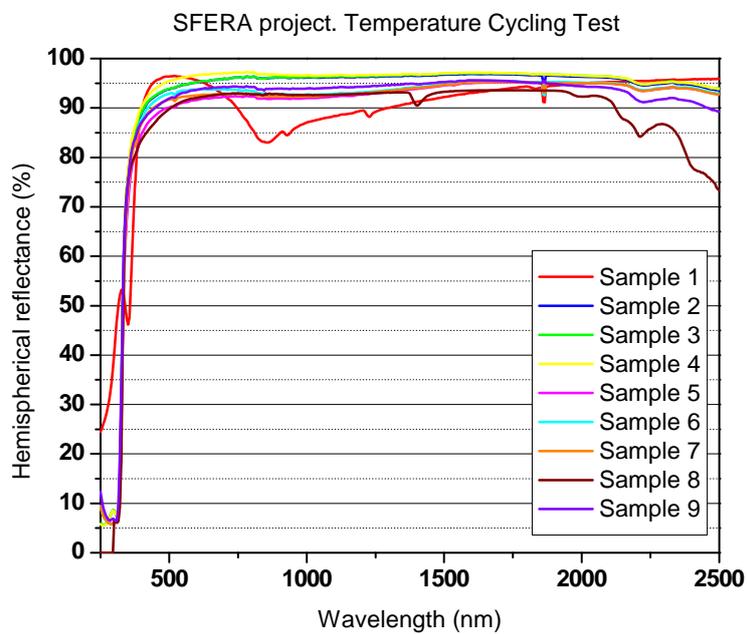
Figure 7 Hemispherical spectral reflectance after temperature cycling test

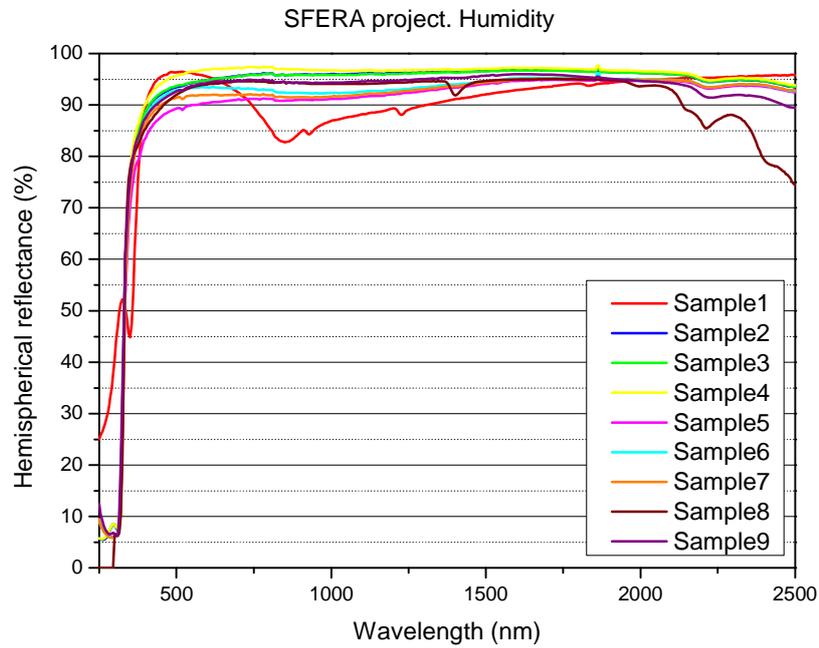
Figure 8 Hemispherical spectral reflectance after humidity test

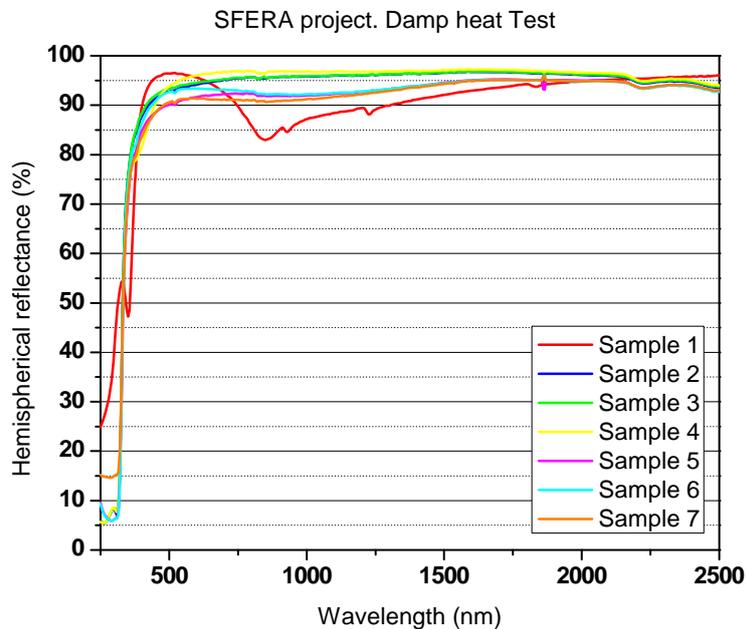
Figure 9 Hemispherical spectral reflectance after damp heat tests (performed only to no cooled samples, that is 1 to 7)

- **Damp heat tests.** This test involved very extreme conditions and it has been applied to the manufacturers 1 to 7, providing interesting results. It seems that it has been one of the most aggressive tests due to the high reflectance losses recorded in the manufacturers 4, 5 and 7). The mirror from the manufacturer number 4 has lost reflectance up to 11.0%, followed by the manufacturer number 5, with a 6.8% loss and the manufacturer number 7 with a 5.5% loss. Manufacturers 1, 2, 3 and 6 have suffered from low to medium losses (between 0.2 and 2.9%). A few representative images show the evidences of degradation after damp heat tests.

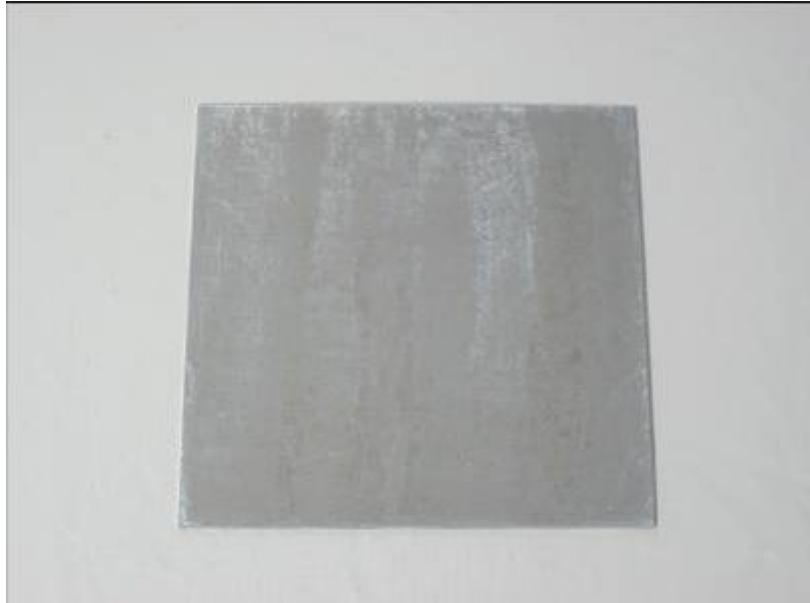
- In terms of salt spray tests**, the samples from manufacturer type 1 (aluminium) presented the highest decrease in reflectance (note that this is referring to hemispherical reflectance in this particular case). Figure 10 shows a picture of sample 1 after the salt spray test, where a visible degradation can be clearly observed. As a consequence of this degradation, reflectance decreased by 8% (see table 5) and reflectance spectrum differs deeply from the initial one (see figure 5). This indicates that it is not recommendable to employ them in salty atmosphere locations (see Figure 10). However, there is no reflectance loss in the rest of the mirrors, made on silver. It was necessary to clean all mirrors with acetone to eliminate salty residues and it has been assumed that, this is the reason why a slight increase in reflectance was detected in some cases. In addition, this test demonstrates the need of special cleaning of the reflectors with acetone or similar, once in a while for these salty environments.

Figure 10 Sample 1 picture after salt spray test

- **After salt spray tests** it can be drawn that just aluminum mirrors are not suitable for salty atmospheres due to a severe reflectance loss after this test. In general, both groups, mirror for cooled and no cooled systems have experienced a reflectance increase. This is due to they were cleaned with acetone to remove salty residues before measuring reflectance, and it caused a very effective cleanliness as a result. Hence, this test demonstrates the need of special cleaning with acetone or similar once in a while for these salty environments.

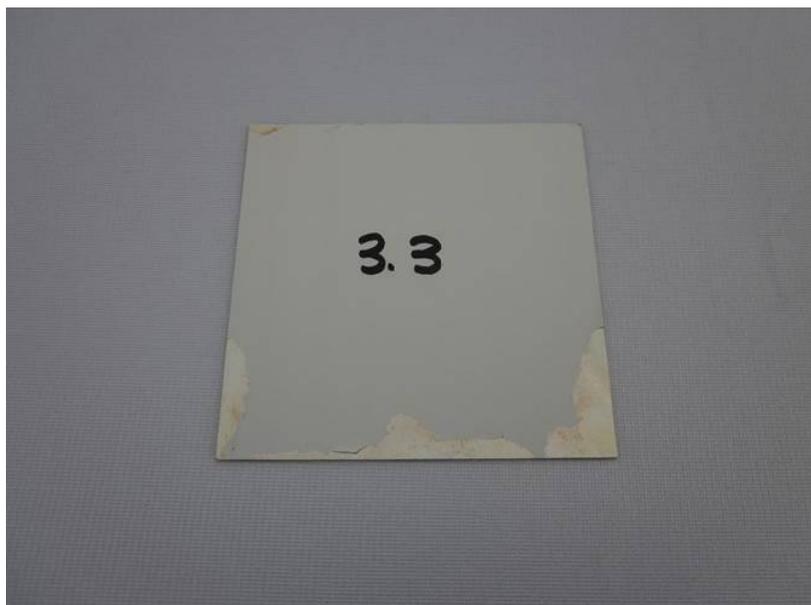
The other two types of thin-glass mirrors (manufacturer number 2 and 3) have suffered minor reflectance losses (between 0.9 and 1.7%). This is probably related to the fact that the mirrors presented the back coating degraded after the tests, as it is shown in Figure 11.

Figure 11 Sample 3 with back coating degraded, after humidity test

- **After the first three combined weathering tests (constant temperature, temperature cycling and humidity)**, and from a cooled mirror systems perspective, minimum reflectance losses were detected in thin-glass mirrors from the manufacturer type 4. This is followed by low reflectance losses in the aluminum mirror from manufacturer 1 (in terms of hemispherical reflectance for this one). In thin-glass mirrors number 2 and 3, the reflectance losses are a bit higher and they presented degradation at the back coating.

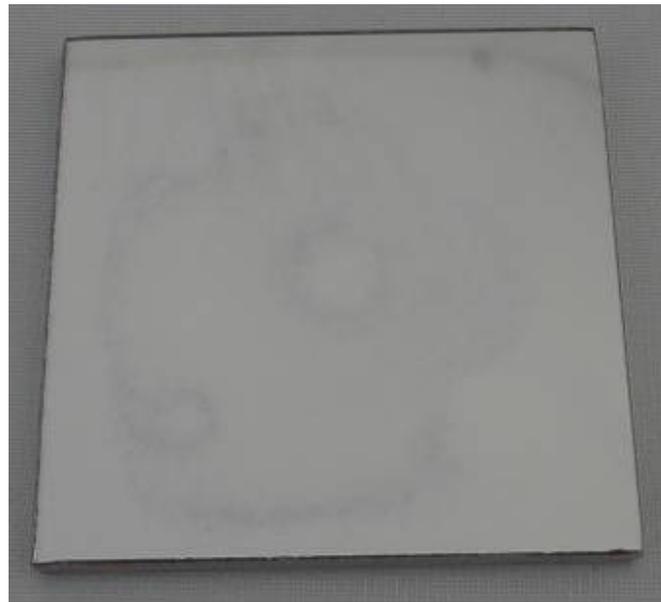
Medium to high reflectance losses (between 1.6 and 4.0%) have been detected in thin-glass mirrors glued to an aluminium support structure (manufacturer types 5, 6 and 7). The increasing degradation throughout the combined weathering tests could be due to a chemical reaction caused by the glue employed at the back to joint the reflector surface to the aluminium structure (as can be seen in Figure 12). This degradation was less aggressive in sample type 6, where protection type 1 was applied on the edges. Therefore, this type of protection has demonstrated to be more effective than the other two options tested, that is, no protection and protection type 2.

Figure 12 Degradation stains due to a glue chemical reaction (sample 5), after humidity test

An increasing degradation throughout the tests was detected in thin-glass mirrors glued to an aluminium support structure (samples 5, 6 and 7). This could be due to a chemical reaction caused by the glue employed at the back to joint the mirror with the aluminum structure. This degradation was less aggressive in sample type 6, where protection type 1 was applied on the edges.

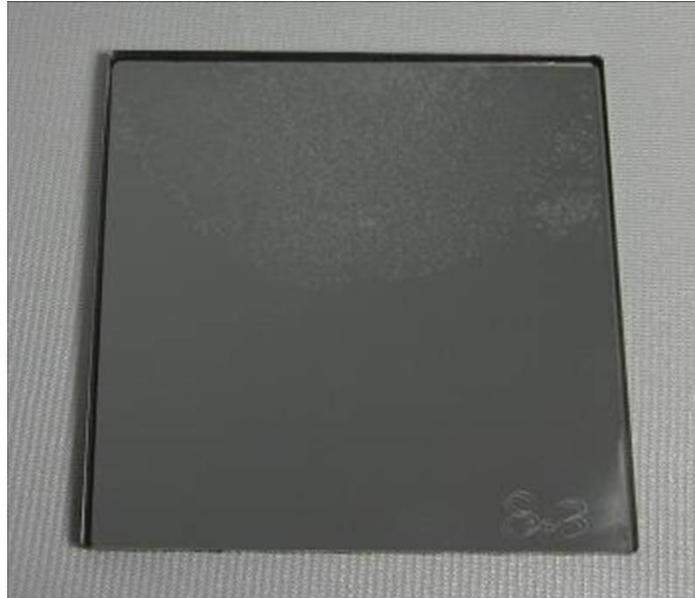
Finally, the highest reflectance loss (8.9%) was observed in the thick glass mirror (samples number 8) due to corrosion of the silver layer (see Figure 13). This degradation started to appear after the constant temperature test and significantly increased after the humidity test. The reason why manufacturer 8 appears more degraded might be due to the lack of protected edges and an insufficient back protective layer.

Figure 13 High corrosion on sample 8, after humidity test

In terms of no cooled systems, the conclusion emerges immediately: very small reflectance losses were detected in laminated mirrors from manufacturer type 9. Nevertheless, the second surface mirror with 3mm thick low-iron glass cover and non protected edges (manufacturer type 8) experimented high reflectance losses. Perhaps this kind of reflector is not a suitable option against sharp weather swings.

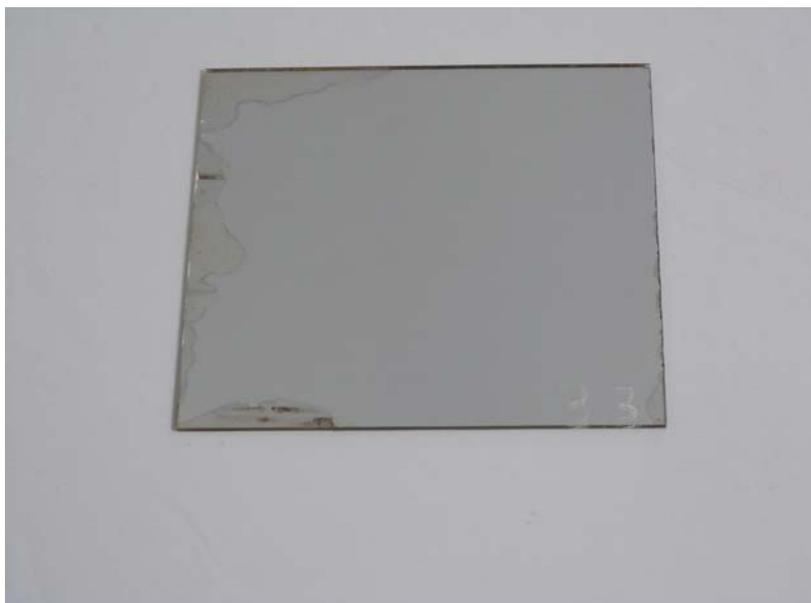
Here, figure 14 shows a typical degradation occurred at the edges. Figure 15 is a microscopic observation about the geometry of the degradation patterns.

Figure 14 Sample 3 edges degradation example, after damp heat test

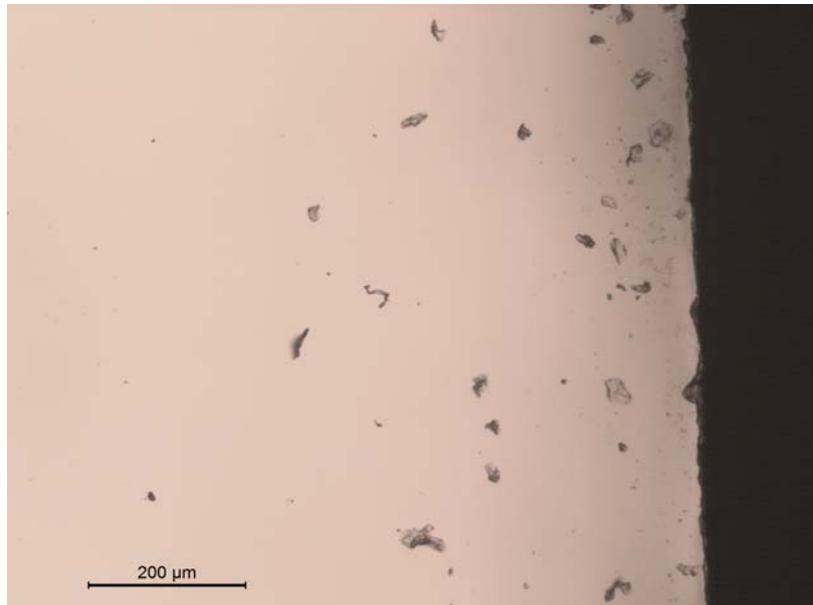
Figure 15 Sample 3 microscope edges observation, after damp heat test

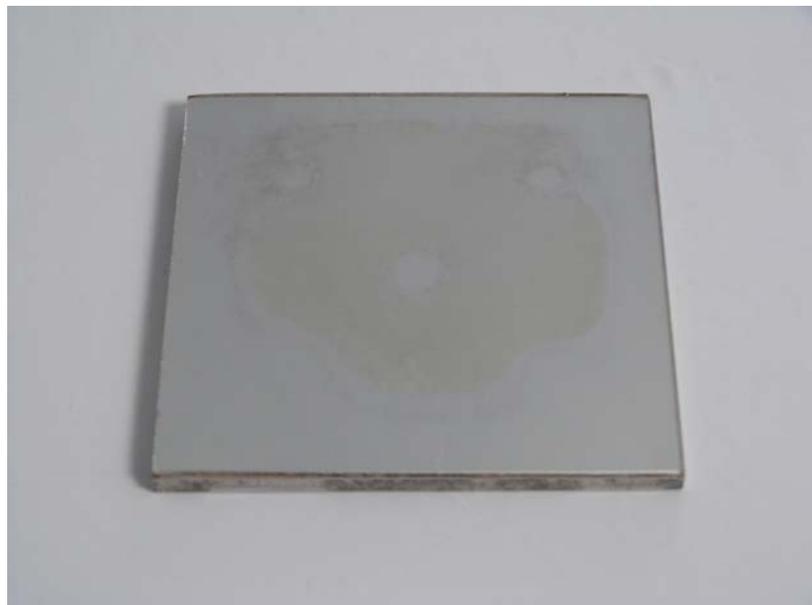
The following two images show how the previously mentioned reaction against the back side glue, has evolved after the damp heat tests in sample 5, which appears certainly more degraded (compare figures 12 and 16).

Figure 16. Sample 5 degradation, after damp heat test

- **Regarding the damp heat tests results**, the highest and surprising loss corresponded to the thin glass mirror from manufacturer number 4. The sample 5 (thin-glass mirrors glued to an aluminium support structure) has also suffered a considerable loss. It is probably due to the lack of protected edges.

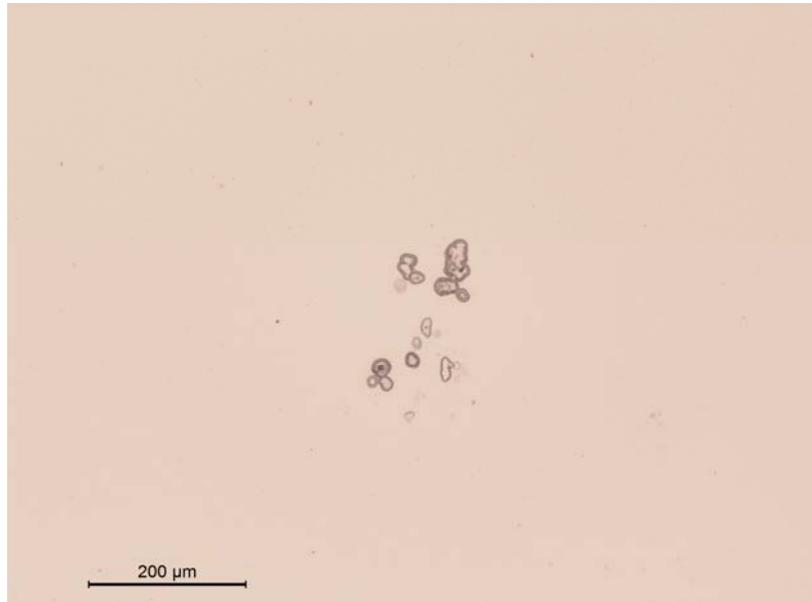
Figure 17 Microscopic detail of sample 5 degradation stain, after damp heat test

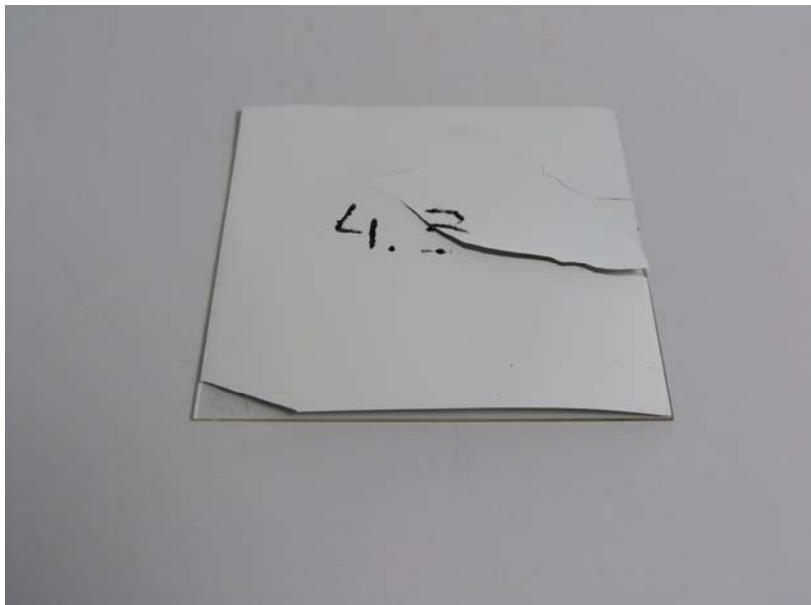
Finally, the next two figures show the reflector layer coming off the glass. This justifies the most serious reflectance loss within all the samples:

Figure 18 Back side degradation in sample, after damp heat test

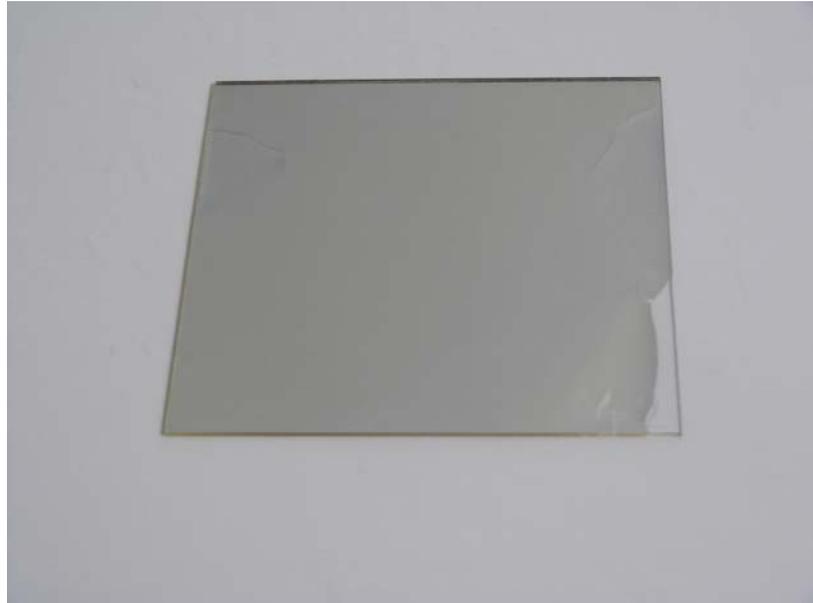
Figure 19 Front edges appearance when reflecter surface loses have occurred (sample 4), after damp heat test
